Effects of bank vegetation in waterways with special reference to bank erosion, shear strength, root density and channel hydraulics

**Effects of Bank Vegetation in Waterways with Special
Reference to Bank Erosion, Shear Strength, Root Density and
Channel Hydraulics**

**A thesis submitted to the Open University
for the Degree of Doctor of Philosophy
Biology Department
September 1992**

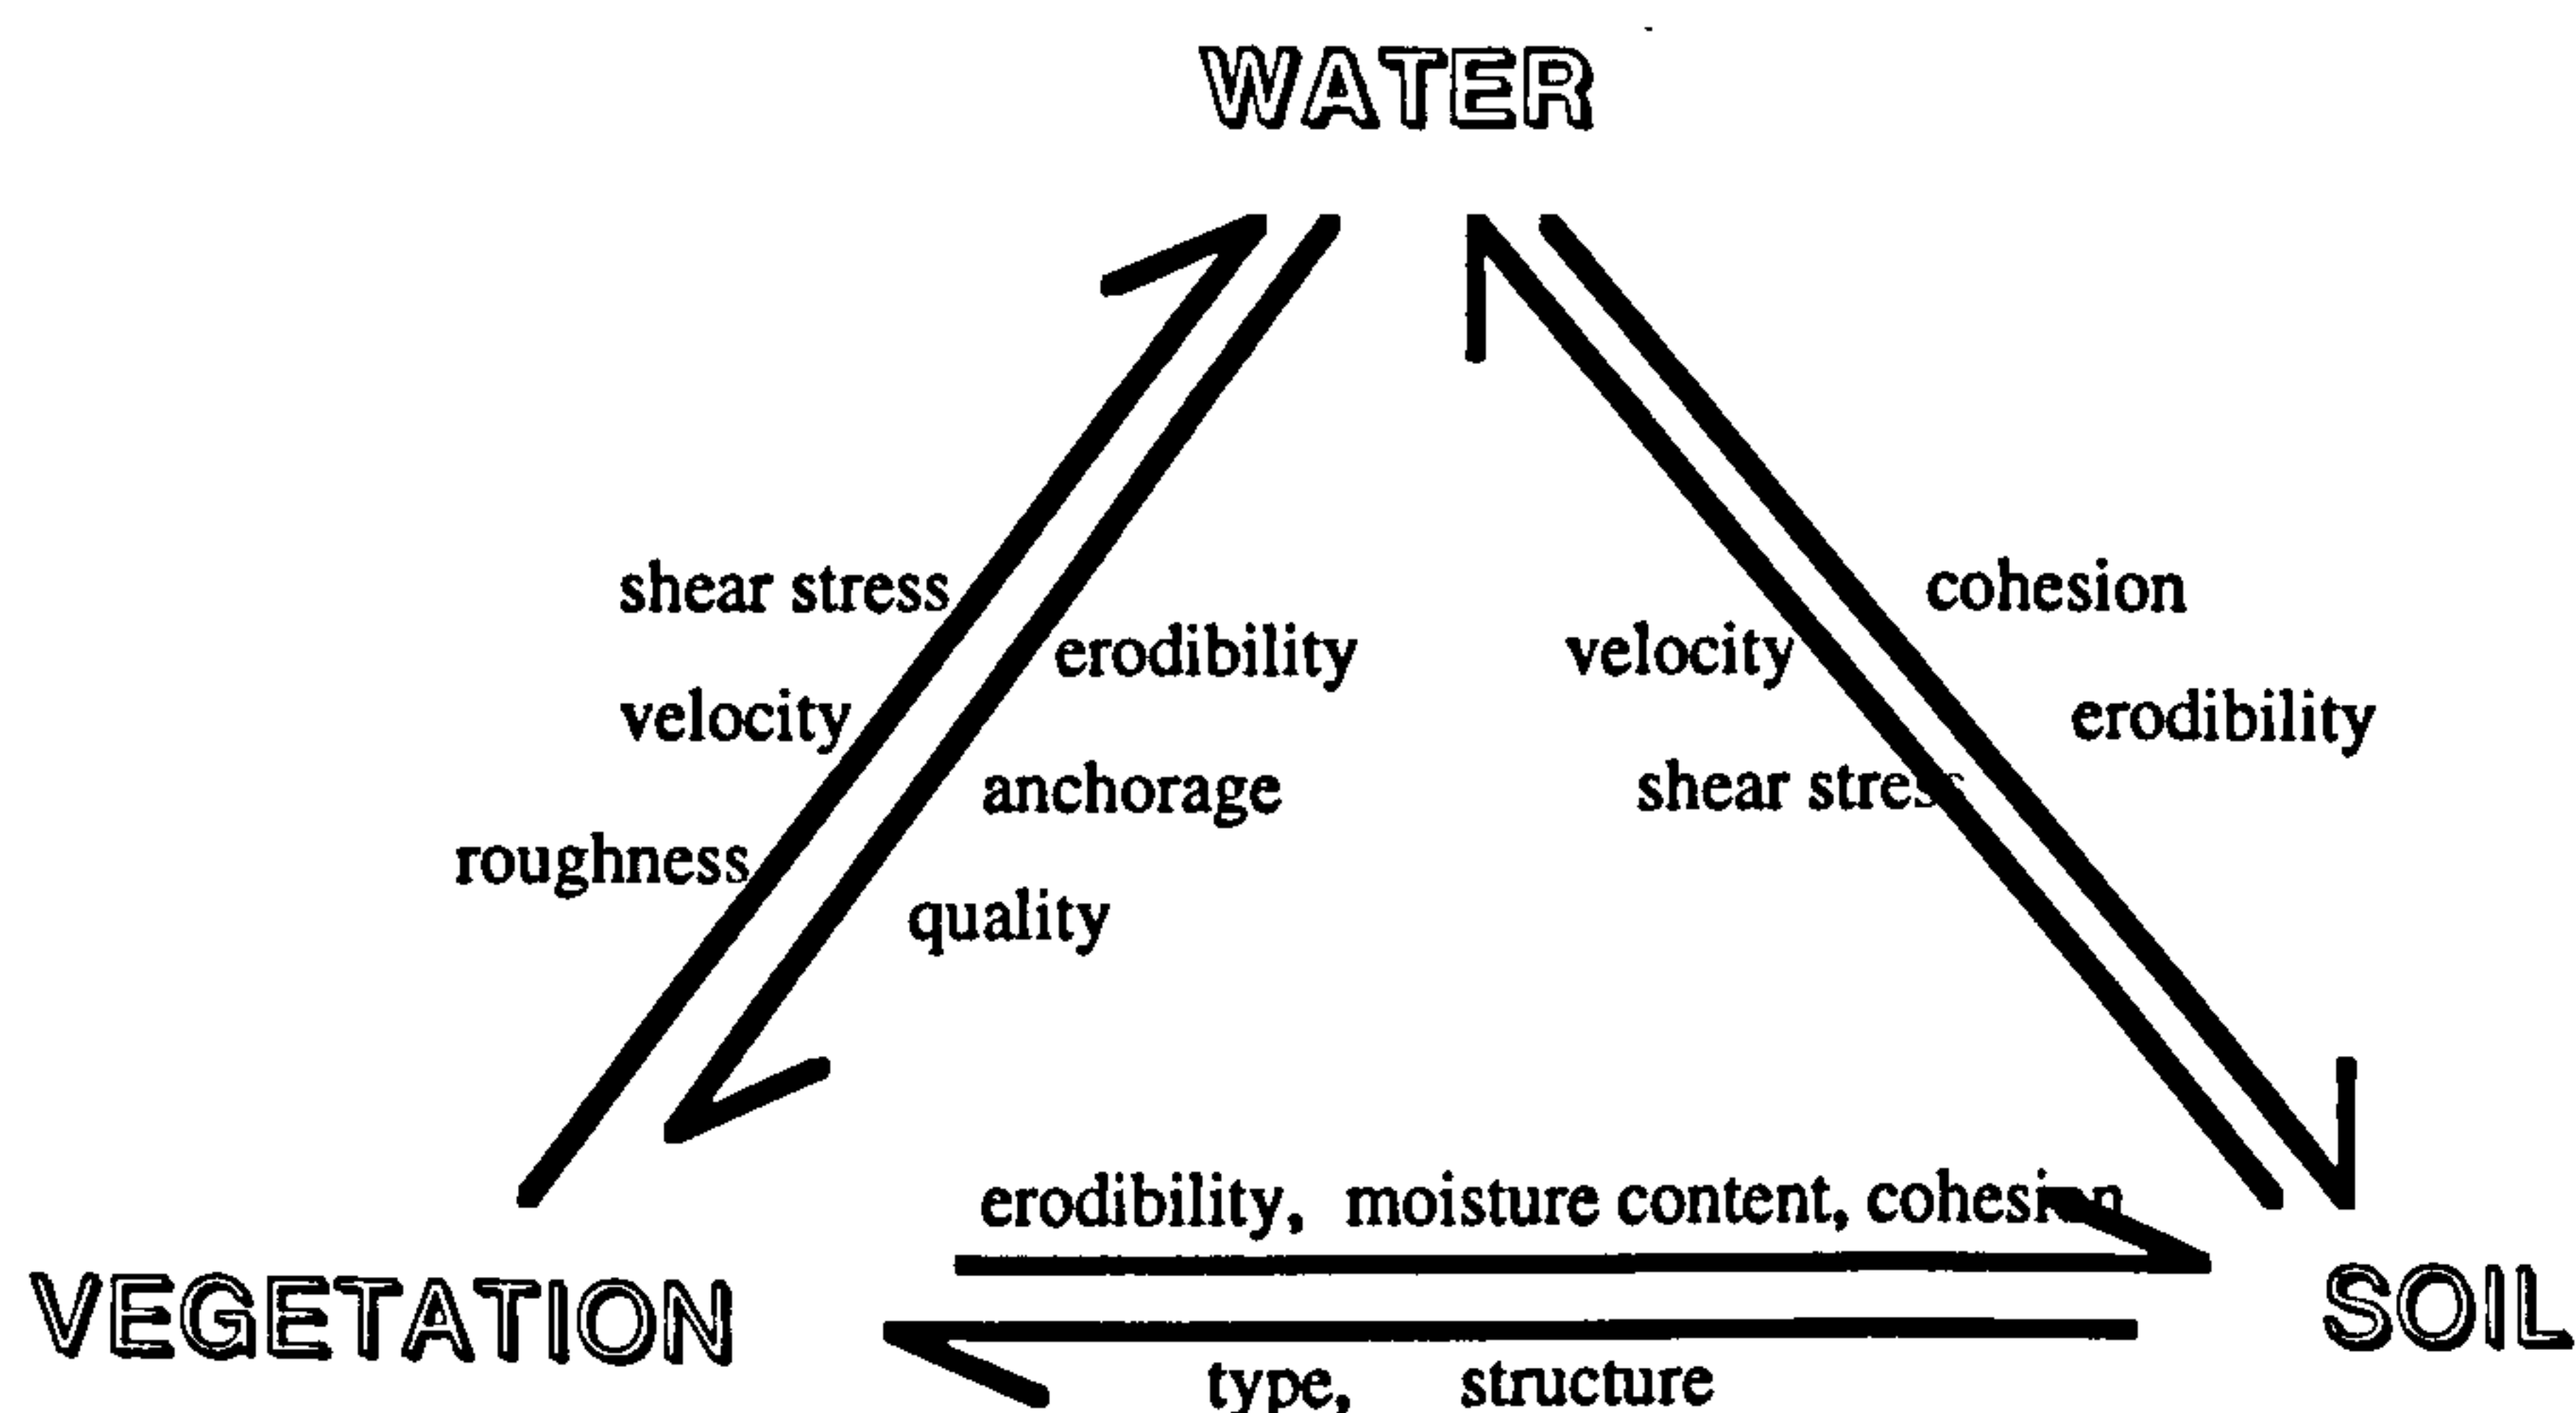
Fig.1.1 : Proposed model of interactions of the principal components of the ecosystem

system in this study. Such a study should explain whether vegetation does present such importance as to be treated as a fundamental component in initiation, increase or decrease of bank erosion under varying fluvial conditions prevalent in a small river. Certain subsidiary factors (see Figure 1.1) such as shear strength, moisture content, soil type will be quantified. An extensive study of all the subsidiary factors is beyond the scope of this study. It would need a team effort with considerable resources of technical assistance and equipment to compile a database that encompass the main as well as the subsidiary components of this dynamic ecosystem.

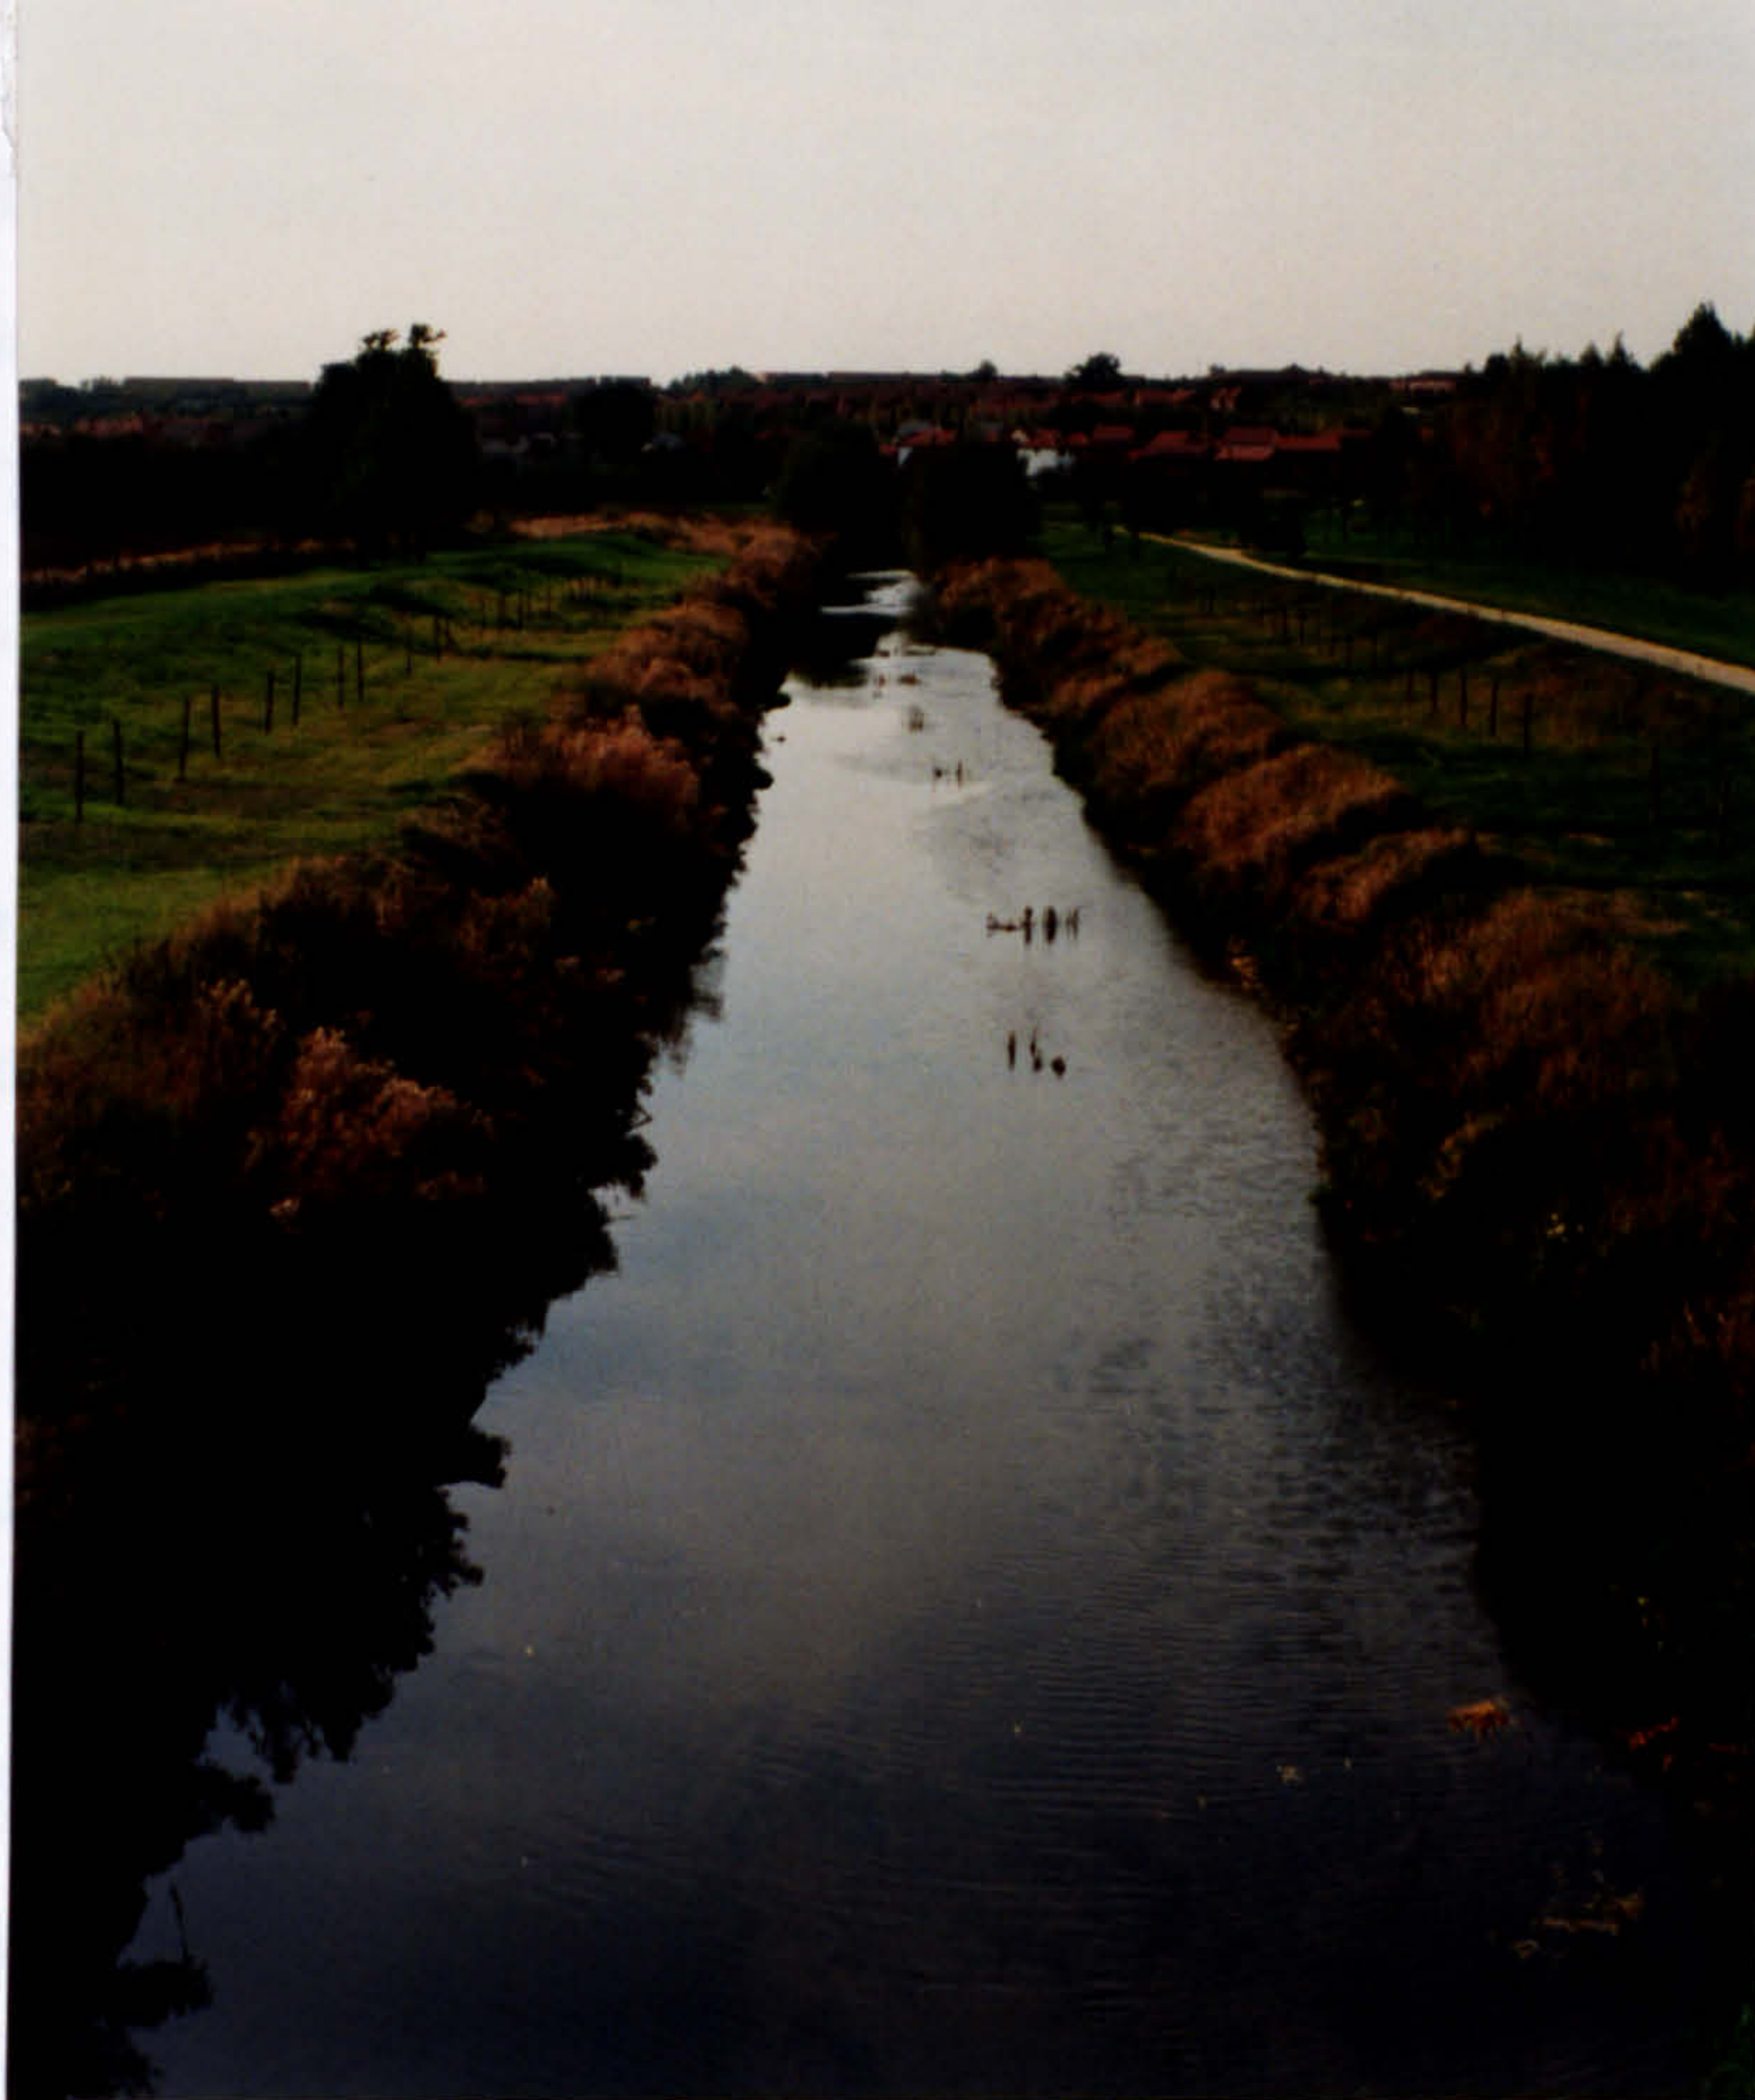
Plate 1. Experimental site in September 1986 (view up-river)
N.B. de-vegetated plots on the banks

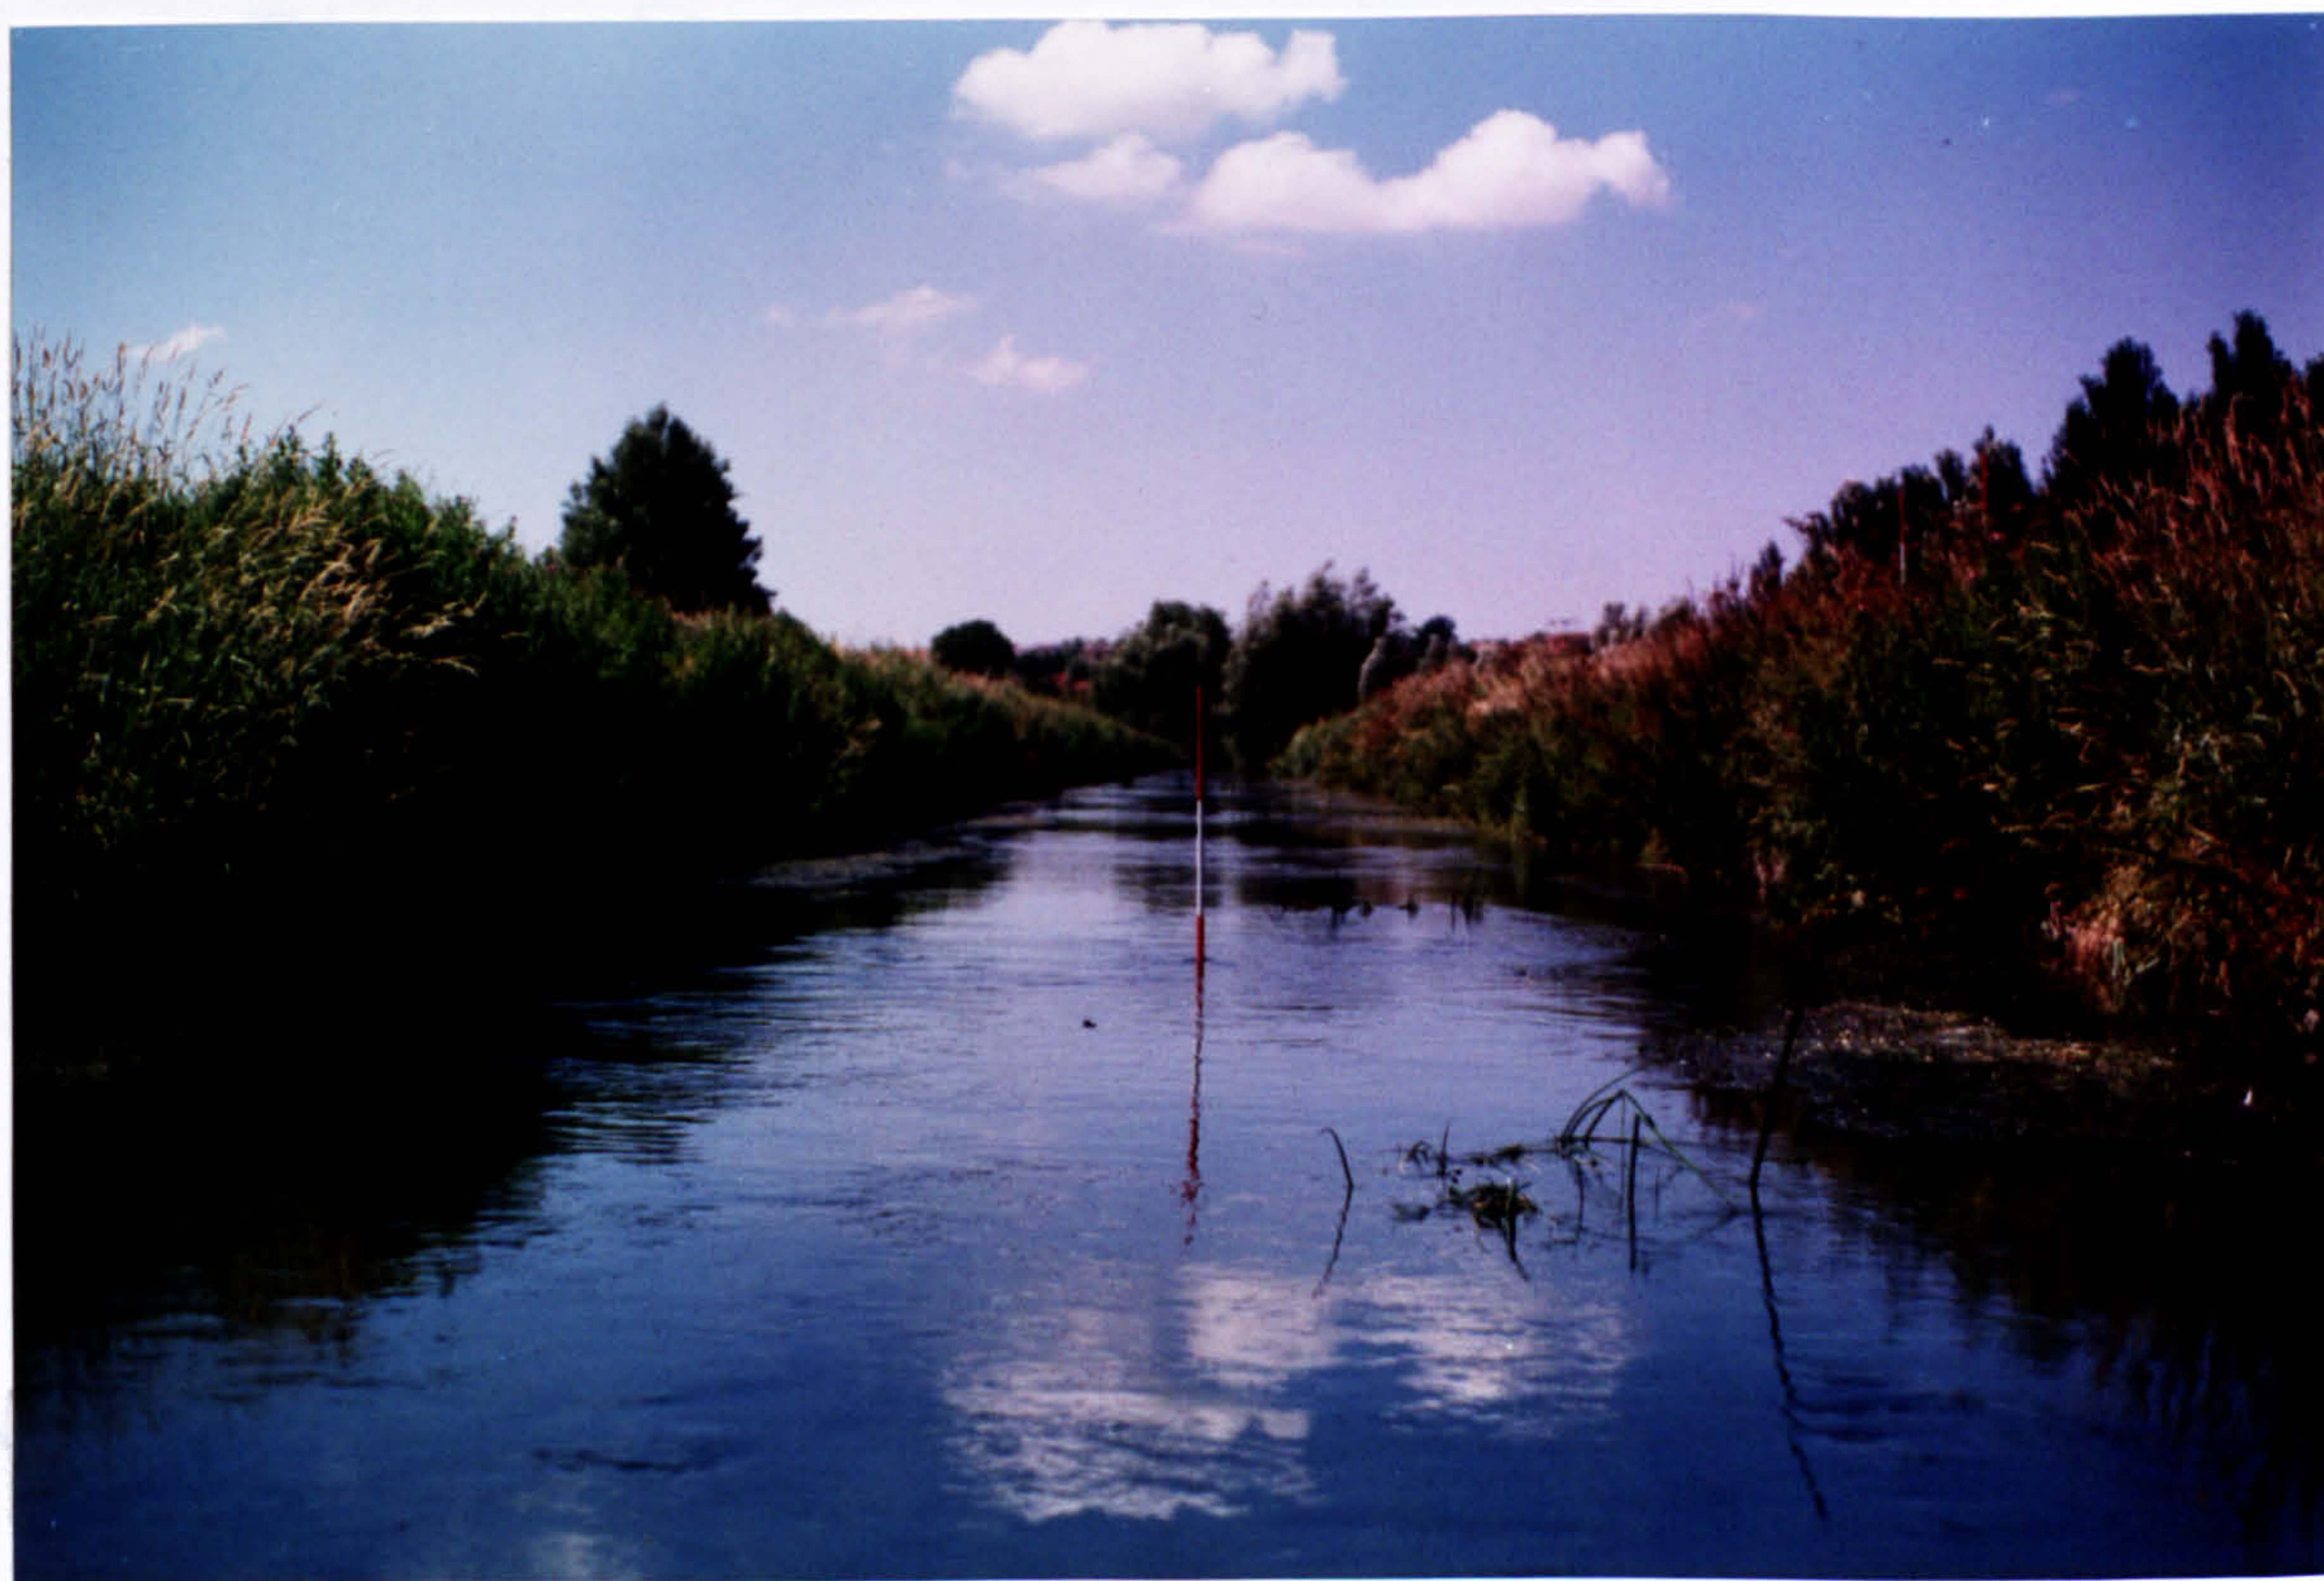
Plate 2. Experimental site in August 1988 (view up-river)
N.B. Plots 2a & 2b with *P. arundinacea* in flower on either bank

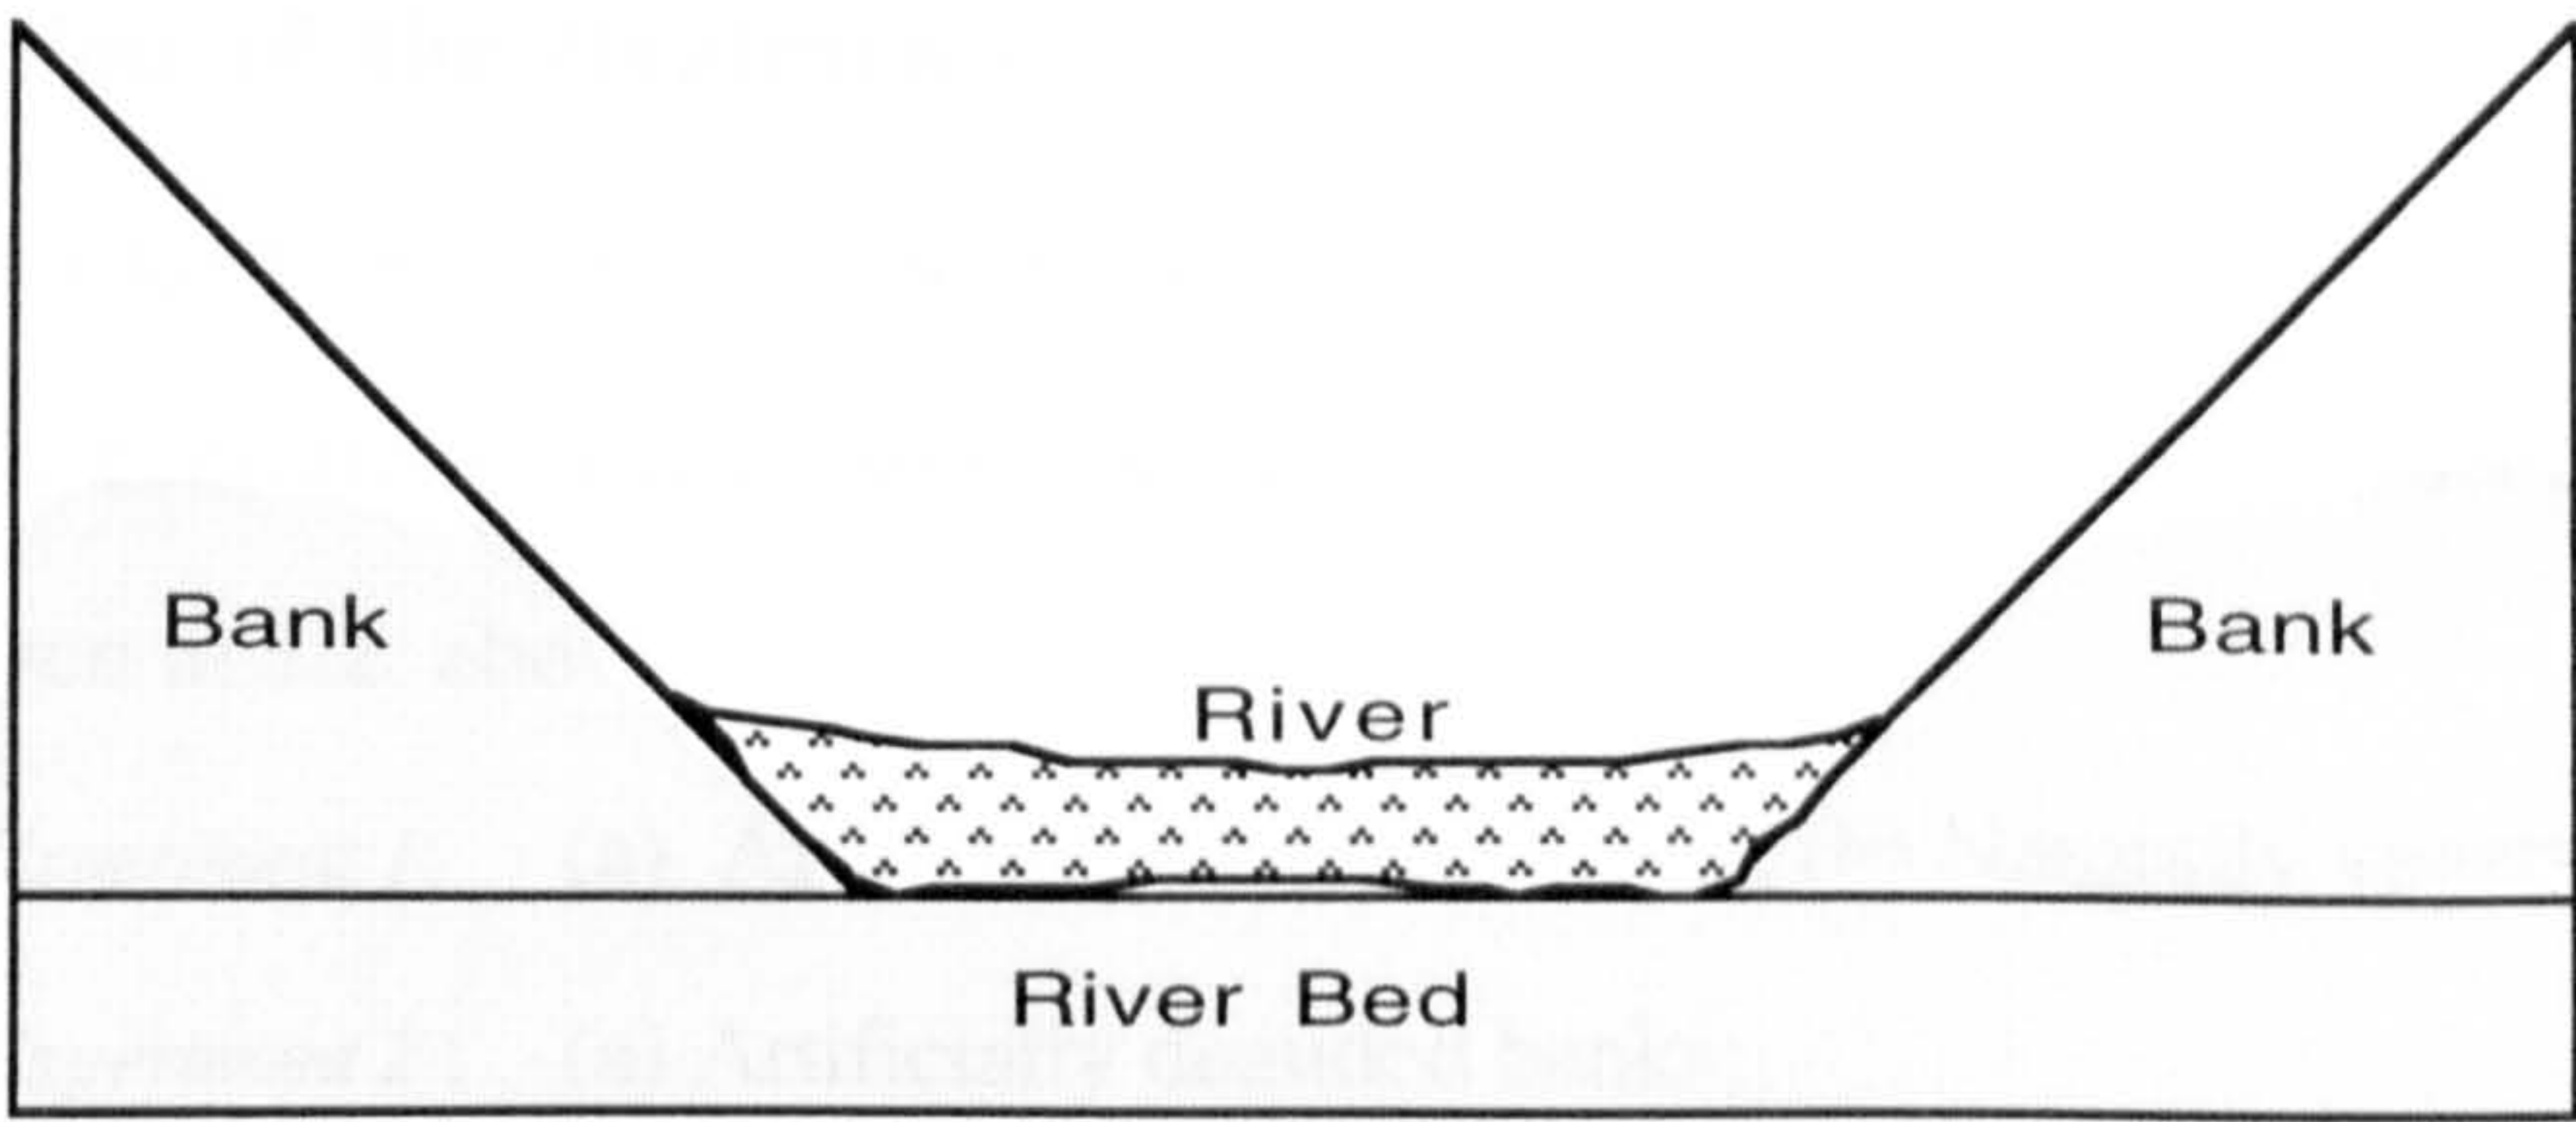
Fig,2.2 : Simplified Geometrical Model of a Cross Section of the river

To identify the causes and extent of erosion up the bank an area of 4 - 5m up from the base of the river bank was chosen. Having delineated the size of the plot (see 2.2.for further reasons), and taking into consideration the length of the straight stretch of the river that could be used, the number of replicates of a treatment per experiment was assigned. The straight channel of the river afforded the advantage of using both banks for similar allocation of treatment plots on either side of the river for all three experiments (see Fig.2.3).

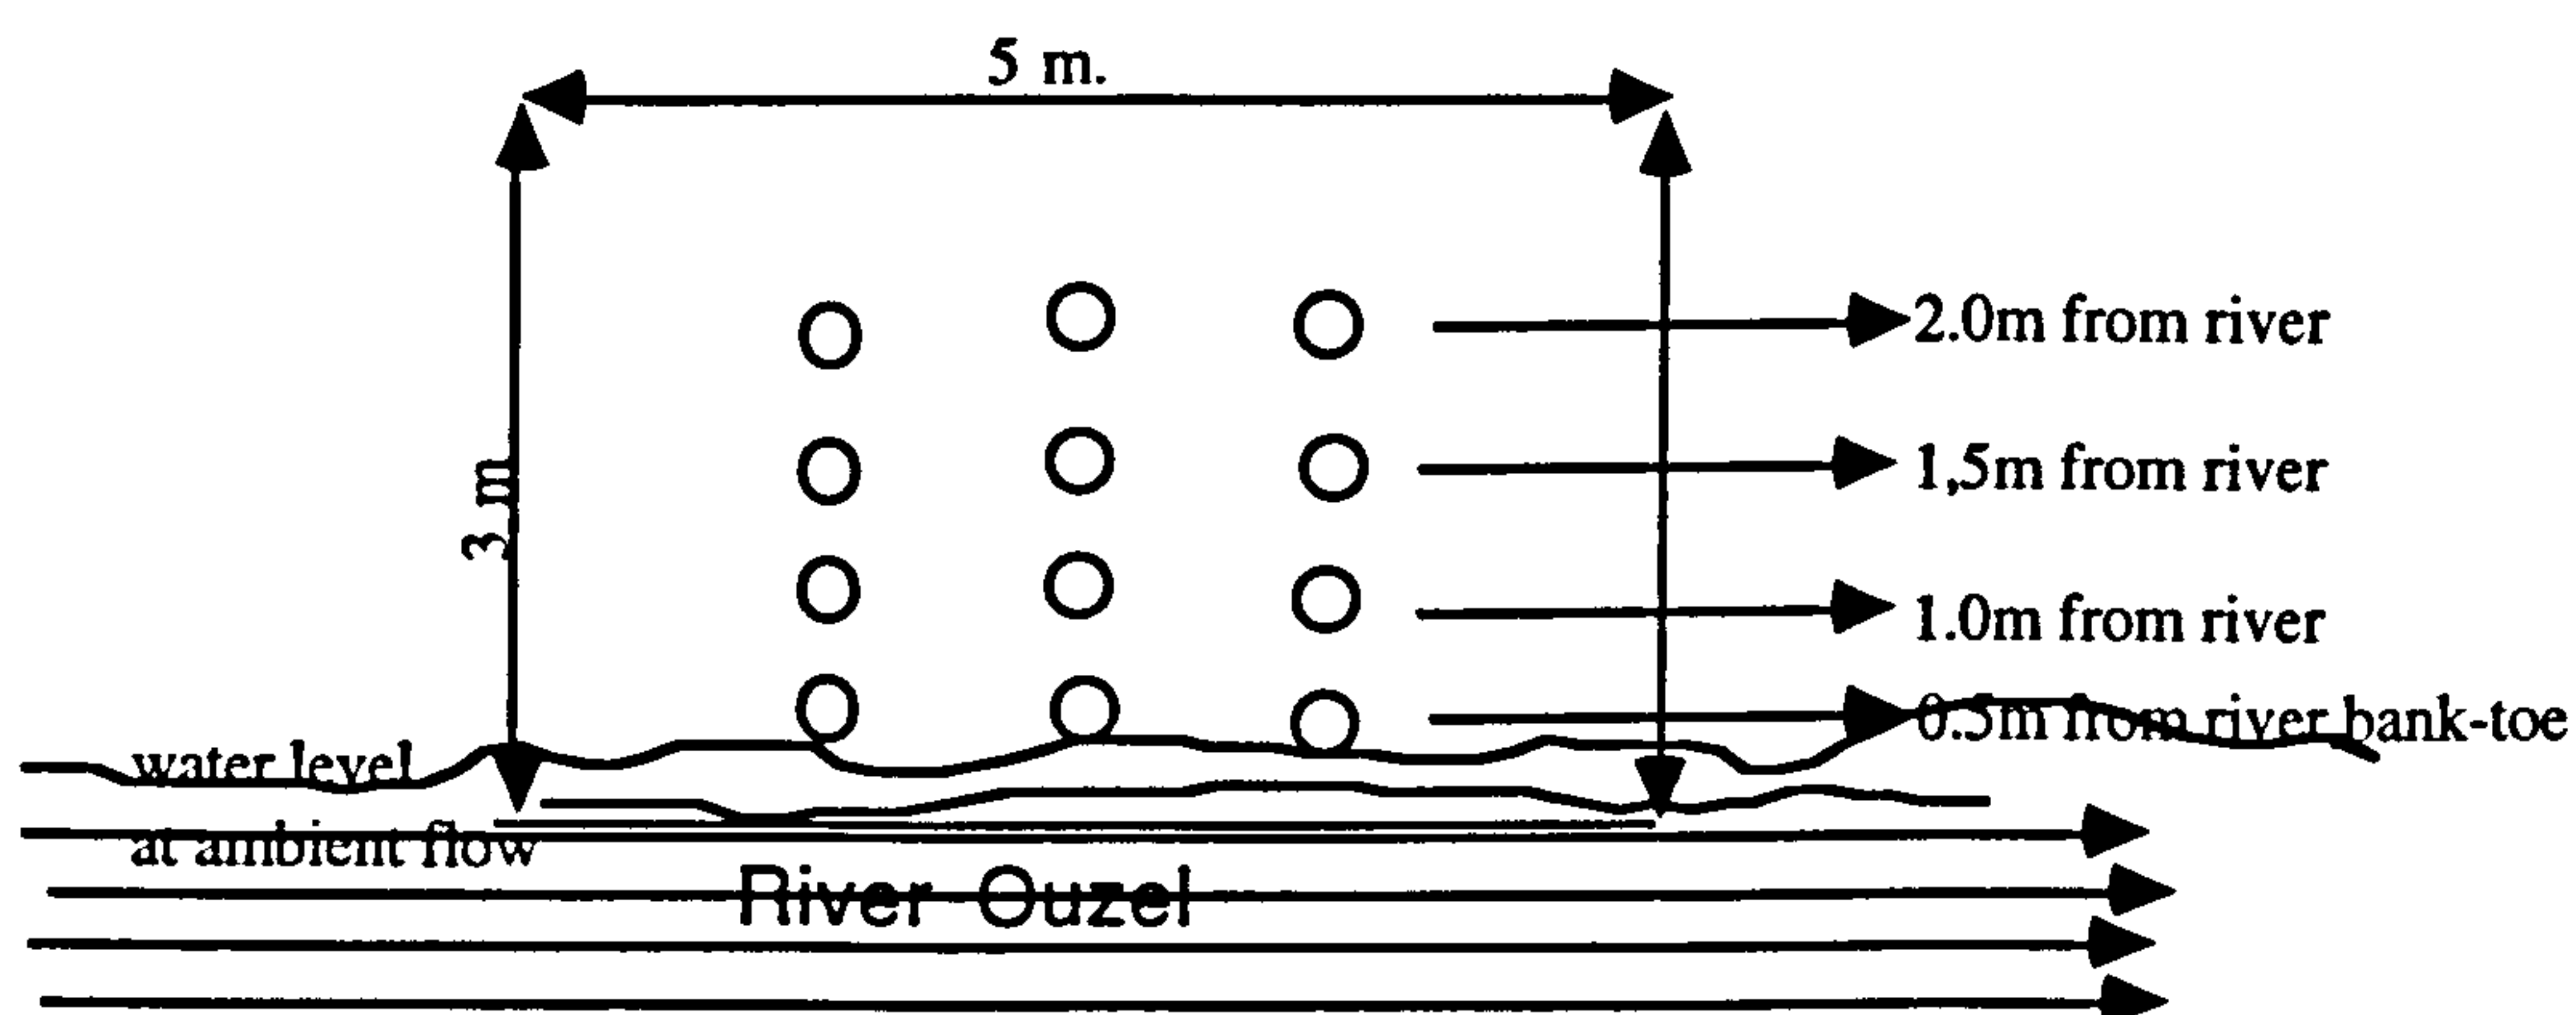
Fig.2.4 : Positions of shear strength, Moisture content and Root-core sampling;

It was decided to facilitate a statistically valid analysis by taking at least three shear strength measurements at three positions on the vertical levels (see Fig.2.4). 1/6th the area of the total treatment is regarded as sufficiently representative of its sub-characteristics (main characteristics and objectives of this study were changes in rates and amounts of erosion under the different treatments).

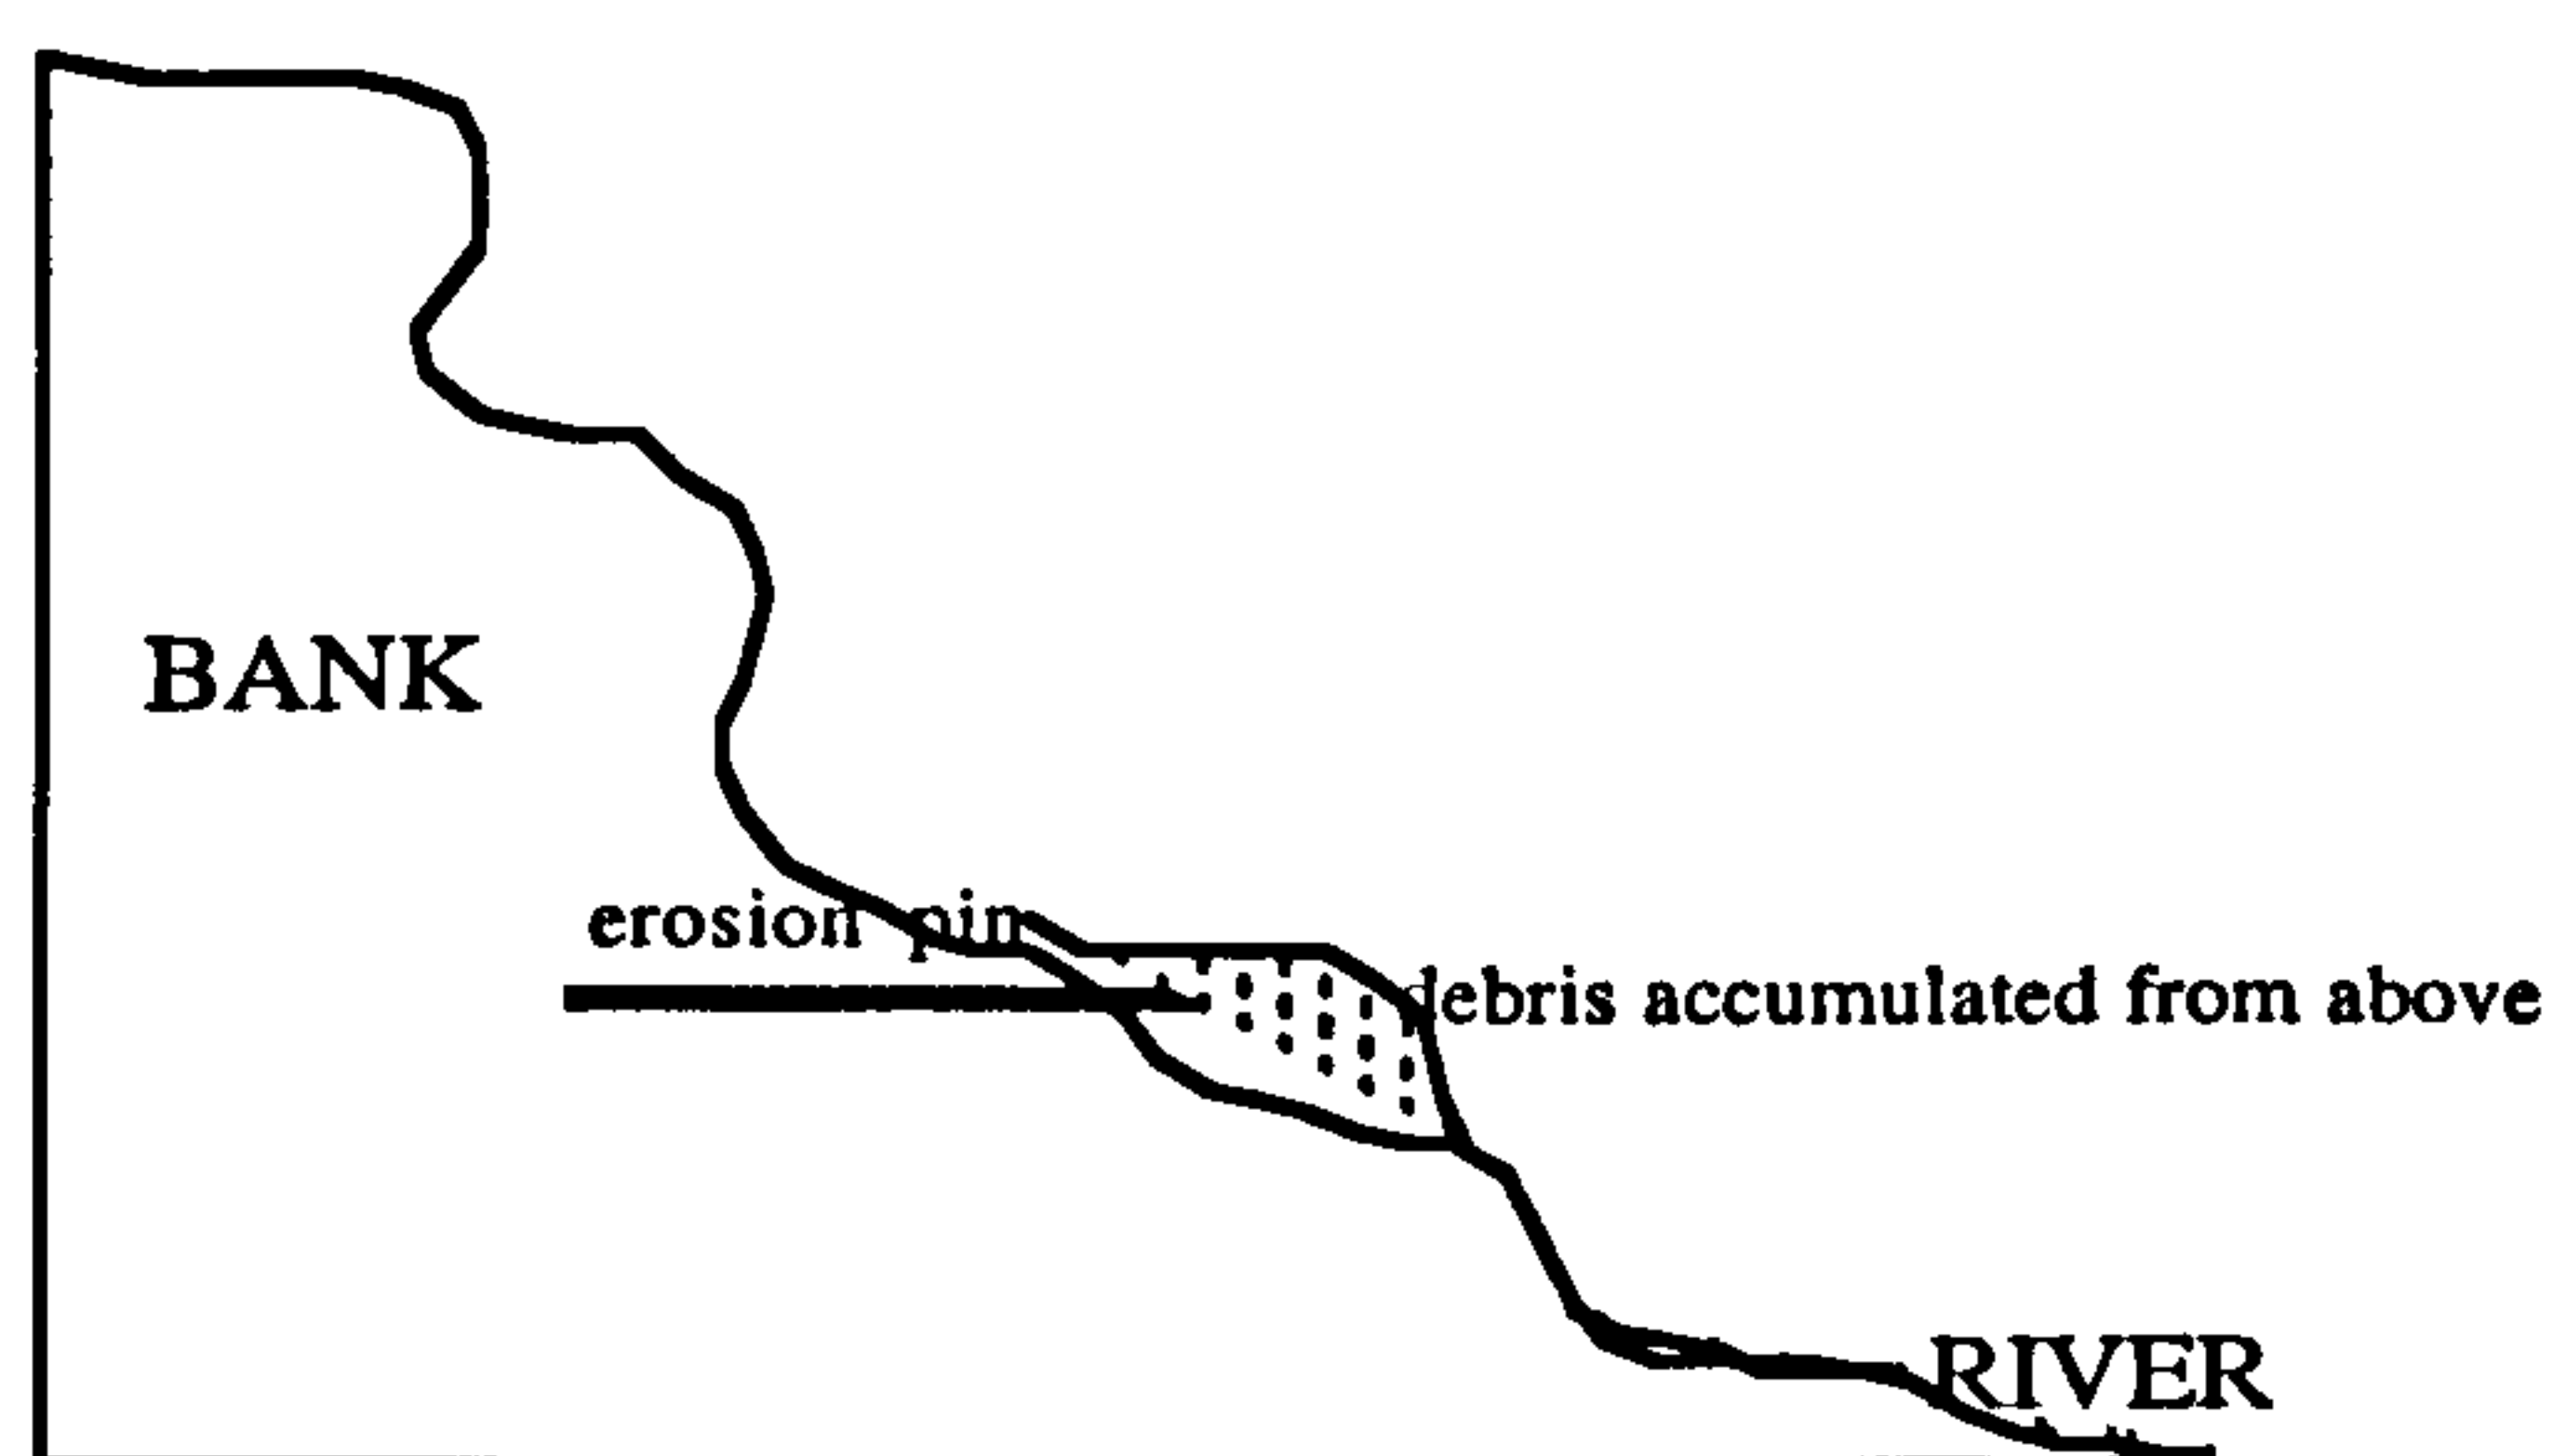
Fig.2.9 : Debris accumulation covering erosion pin

ii) the pin head itself was capped with a red plastic head barely larger than the pin head itself. This was allowed to protrude from the ground (approximately 2mm) and noted in the records. In some cases both methods were adopted together especially prior to winter flooding. In summer this approach helped to prevent considerable damage to the vegetation caused previously by trampling and handling vegetation in search of pins.
